Adadi Mariam Church:

An Ethiopian historical jewel.

Authors: Samuel Tekle & Degsew Zerihun. ©

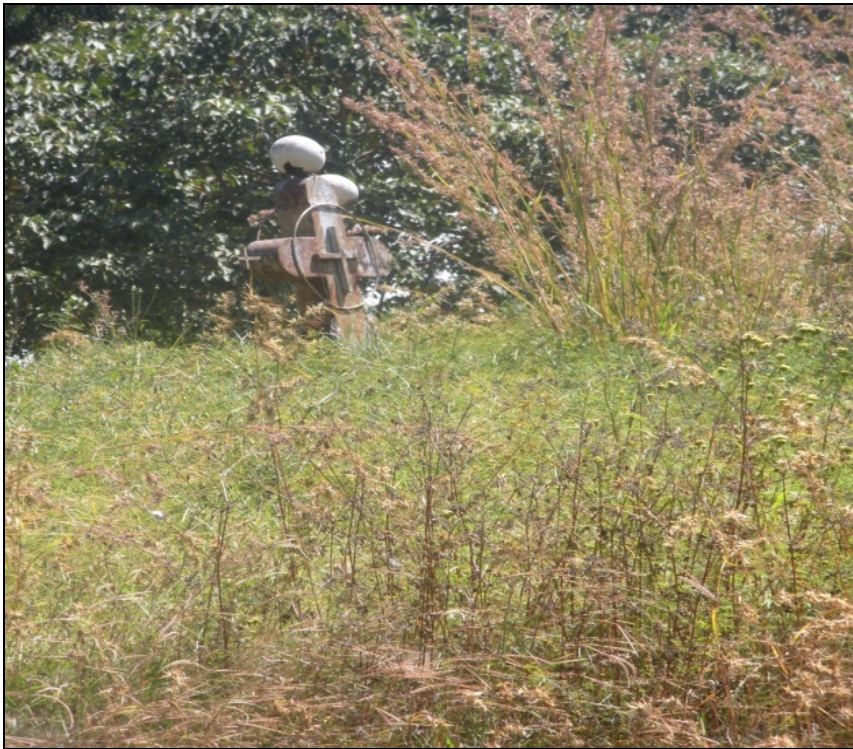
Adadi Mariam rock-hewn church is not visible for viewers from far even within the compound. The Anfar grass on the acme of the church and cross including five Ostrich eggs on the cross can be seen if one is close to four to three meters near to the church. It is because of the subterranean nature of the church. Adadi Mariam rock hewn church is a type of rock-hewn cave church excavated in wards from a more or less vertical cliff. It is also partially separated from the main rock with various degrees of attachment to the rock.

Fig 3.1 Anfar and the cross on the acme of the church

The Biological factors for the damaging of the church are both plants and animals. The anfar tree on the acme of the church takes the lion share for the deterioration as the roots of trees have caused cracking on the church. Besides the anfar, the surrounding trees, lichens and mosses also have the contribution for the damage. The Anfar tree also plays a significant role by inhabiting animals like birds and rats. The dead bodies of the animals as well as plants themselves facilitate the growing seeking of water during dry season.

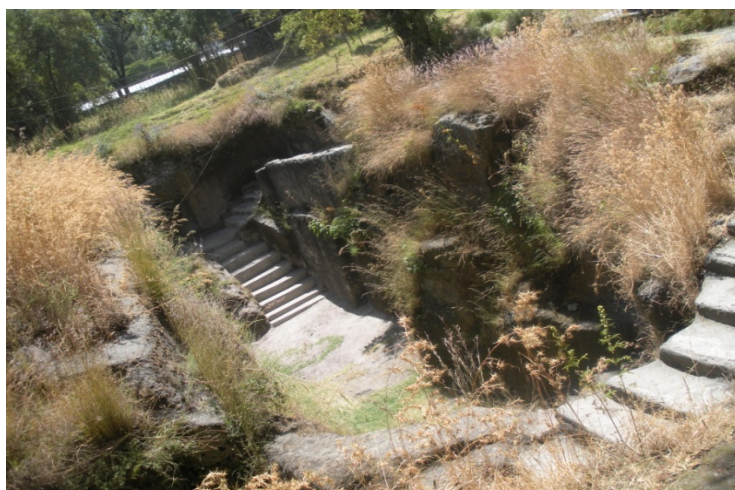
Fig 3.2 Entrances of men (left) and women (right)

From the exterior the architectural feature of Adadi Mariam Church is not that much attractive as compared to the rock-hewn churches in other parts of Ethiopia. The three entrances of the church have many stairs; two of them have twenty one stairs that represent the twenty first monthly festivity of Saint Mary.

Unwise conservation and electrical installation works belong to the deterioration factors of Adadi Mariam rock-hewn church. The entrancing staircases lost their religious context as a result of unwise conservation works. Before the restoration, each entrancing had 21 stairs but now it is changed by modern ceramics and the numbers of stairs are decreased. The roof of internal parts is painted by white colours that lead to the loss of the original rock color which was black. A big metal operational work conducted to support the roof because of cracking also affects the church's original character. For the sake of electrical installation work some roof and wall parts are drilled. Some of the drilled holes are closed by wood.

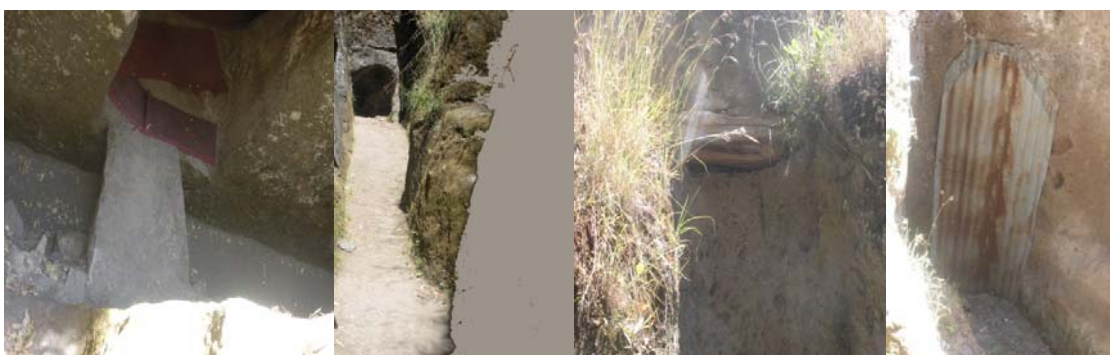
Fig 3.3 Drainage systems and the bridge

After finishing the stairs in wards, there is a drainage system or sewerage that surrounds the church. Roughly it is half meter by half meter. To pass the sewerage, there is a bridge like stone naturally attached to the main rock. It is true for all entrances. The sewerage makes more or less circular shape and passes to Adadi River in the east of the church. The final exit wall of the sewerage is the main rock, approximately, four to five meter height and one to two meter width. At the top of this wall, there is a bridge made from wood and stone which seems a recent phenomenon and at the bottom it is closed for safety. This big sewerage wall might be created to transport unnecessary fractured rocks to the river during excavation.

- In order to prevent further deterioration of the church, trenches and drainage systems should be cleaned. This will minimize the amount of infiltration the rock masses.

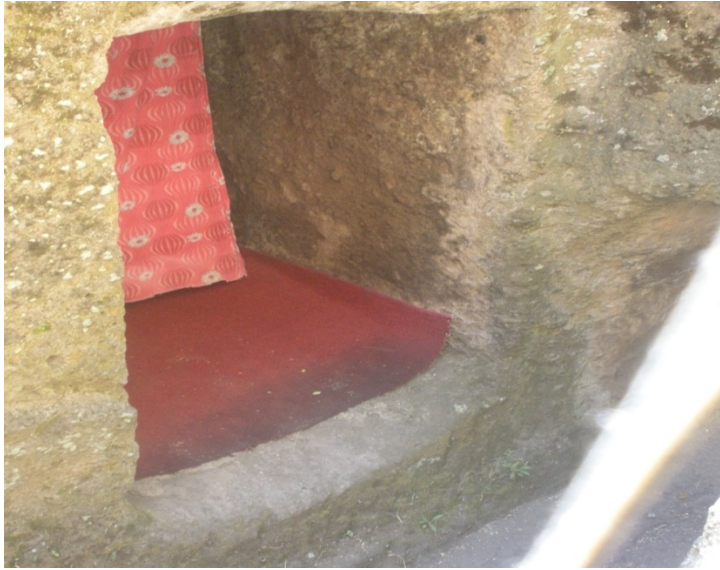
Fig 3.4 Men entrance

There are more than twenty posts that support the main structure of the church. The height as well as the thickness of those posts is different. For instance, the height and thickness of the men entrance post is 110x2.15 meter. It does not apply for the other entrance posts. Beside those posts, there are connectors in four directions, the structure with the face rock at each head corner.

The presence of posts might be resulted from understanding the softy nature of the rock and to strengthen the structure.

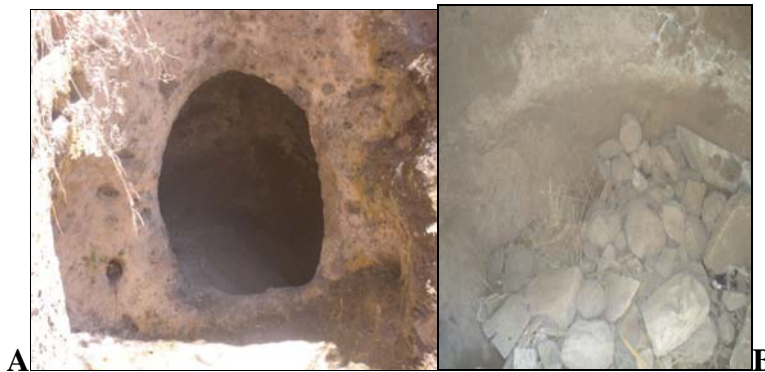
Fig.3.5 The praying cell and its interior.

The praying cell and other caves which purposefully excavated for resting of saints bone are also among the exterior architectural features of the church. The cell which is found in the eastern parts of the church or just left of priests' entrance stair is purposefully excavated for praying place. It is excavated on the main rock at a place of 1.7x1meter and it has the capacity to serve three people. However, it is not comfortable because of the top of the cell, i.e. the roof is downward curve and decreases its height at left and right side. There are also very small cells near to it. The other cell is found in northern part of the church or just between the entrance stairs of the priests and men. It is in the mid part of the face (main) rock. It is without stairs but fractured natural rocks helps to move up. Within this cell, there are bones of saints with in metal box who are not yet clearly identified.

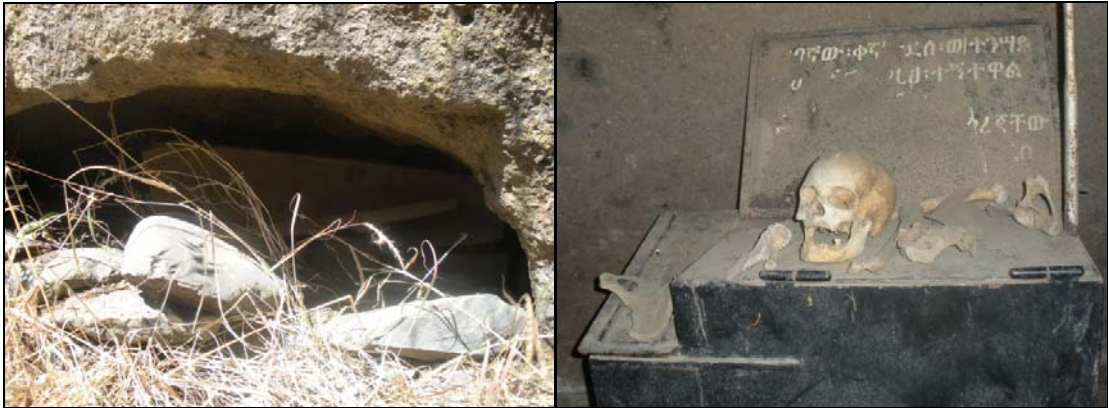
Fig 3.6 The cell with saints' bones

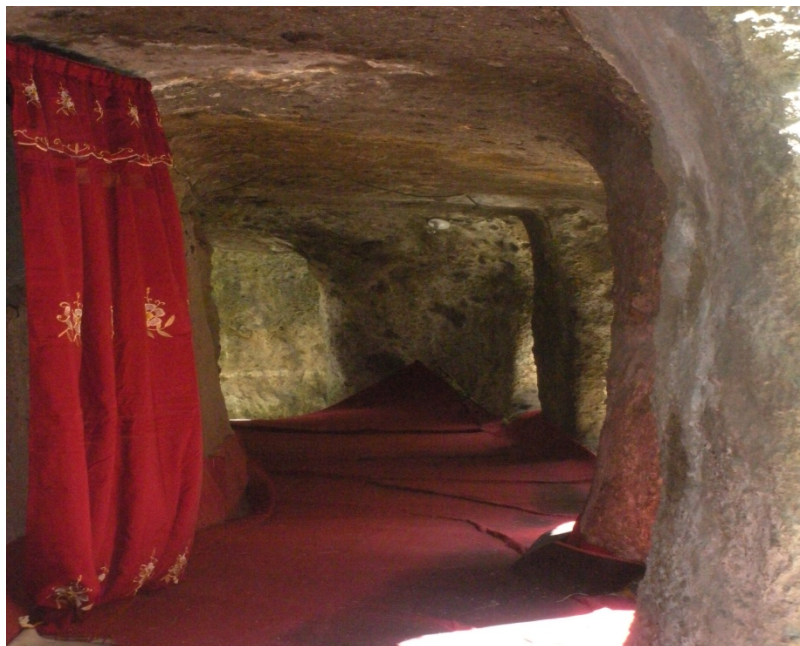
Fig;3.7 Part of the church's interior

The internal part of Adadi Mariam rock-hewn church consists of three parts. It is the common feature of Ethiopian orthodox churches, either rounded or rectangular ones. They are Qene Mahlet (nave). Qeddest (the middle one) and Meqdes (the Sanctuary)

Qene Mahlet is the first part where hymns are sung and cantors stand. At this part the community at large has ready to access. This part of Adadi Mariam rock-hewn church has seven meter width. It has a circular form with door and windows. The entrance door towards the north has 1.7 meter high and 1.1 meter width. It is more or

less squared comparing with other doors. Windows measure 1x0.9meter towards the north and 95x90 centimeter towards the south with 70 centimeter thickness.

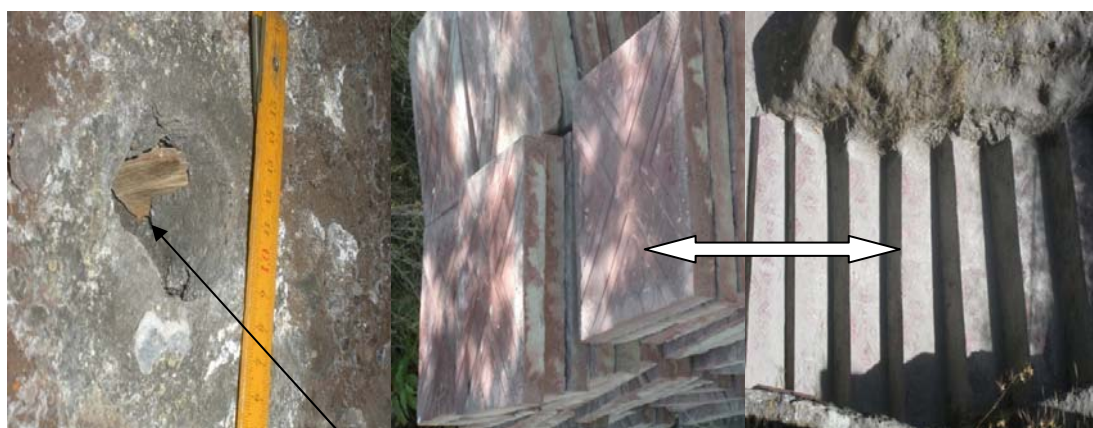
Fig 4.4 Restoration works

According to the information obtained from the administrative head of the church, the church has got supports twice from the ARCCH in 1992 by the financial aid of Switzerland to conduct restoration works on both the interior and exterior parts of the church. However, the restoration work was conducted not in a proper way. ARCCH proclamation state that

The restoration work seem a writing of new history as the staircases are changed to modern ceramics as well as the roof of Qene Mahlet and Qeddest are supported by a big metal. The horizontal crack of the roof is filled with jesso and the color changes to white from its original black color.
